# DDASaccident645

# DDAS Accident Report

INCIDENT INVESTIGATION FOR [Demining group] - MINE ACTION TEAM - JORDAN

TASK NAME: JABIR 1 (477), NORTH BORDER PROJECT, EAST SECTOR

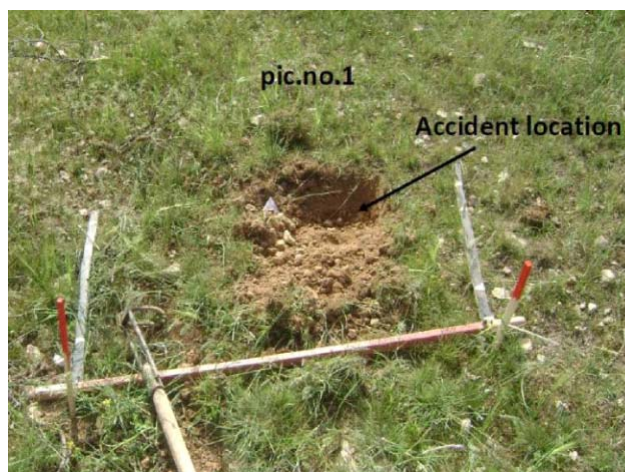
1. The deminer didn't carried out the visual check it was found there was stones in the clearance box.
2. He didn't apply the correct procedures in cutting the grass and removing stones according to the SOPs.

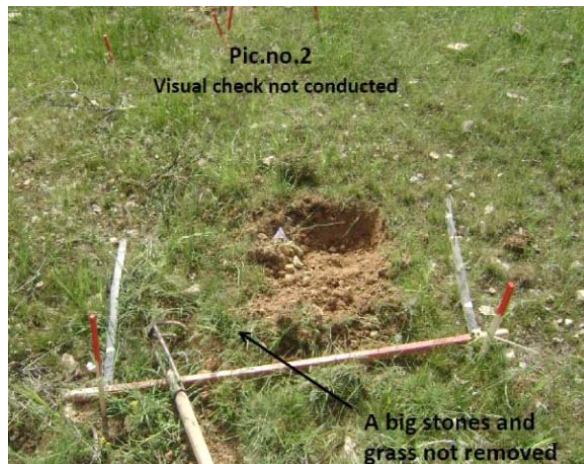
3. The base stick is placed in the right place and marked.
4. The deminer searched and carried out the raking for the signal outside the clearance box area.
5. The marking pickets are put according to the SOP.
6. No damage found in the heavy rake.
7. Raking depth was 11 cm which is less than the required depth.
8. The deminer buried the grass on his left side near to the cluster where he is working at instead of putting them in the rubbish pit it is violation of the SOPs.
9. He didn't use the light rake.
10. According to the medic who was watching when the accident happen it was a strong explosion followed by lots of dust.
11. There was no crater found after the mine blast which means that the mine was almost on surface or semi surface.

The deminer has not followed the correct drill. Using heavy rake in grass area is always risky due to the roots and due care should be taken. This incident happened due to the deminer individual mistake.

It is recommended to issue a written warning order to the deminer.
